Main Hall, Union Station

Washington, DC

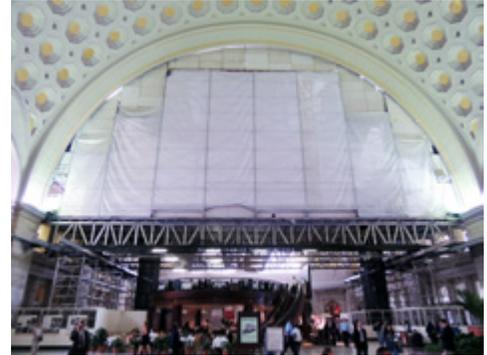
In addition to hard hat and fall safety regulations, an above-head protective net was installed to mitigate future incidents. During the renovation of Bay 3, a significantly stronger netting was placed over the Main Hall's centrally located restaurant. The same technology used to protect the vice president during the US Presidential Inauguration in 2008 was used to construct the heavy safety netting suspended between the renovation and the restaurant patrons below. As the renovation moved from bay to bay, the scaffolding and safety precautions followed. It was obvious that strict and organized safety protocols were necessary for this public jobsite to remain accident-free.

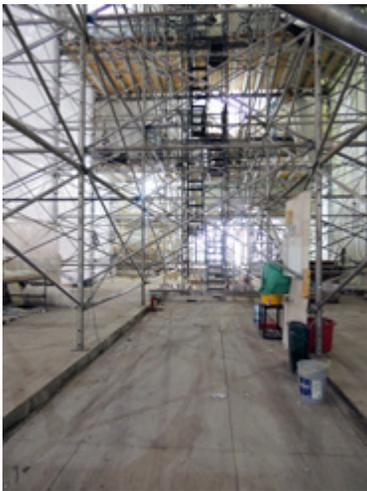
The location above the Main Hall's dome where the duct was to be installed is 115 feet high above the floor. Contractors accessed the workspace by navigating two levels of tall scaffolding tied together by a web of narrow ladders. It was impossible to carry the ductwork up these ladders. Norwood and building engineers were challenged to devise the best method of delivery. Site officials quickly observed that delivery during operational hours was unfeasible.

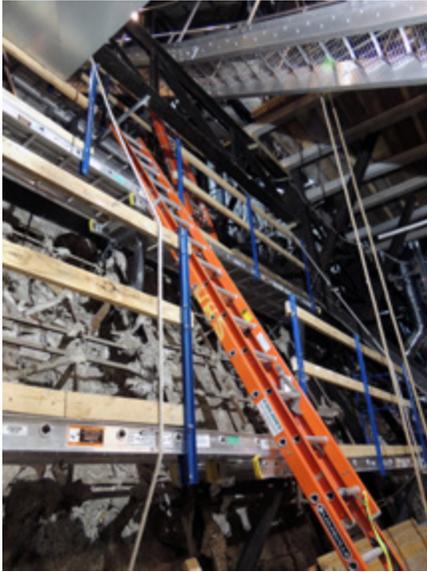
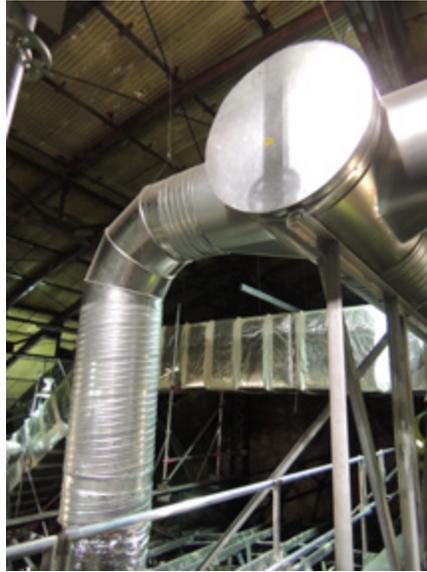
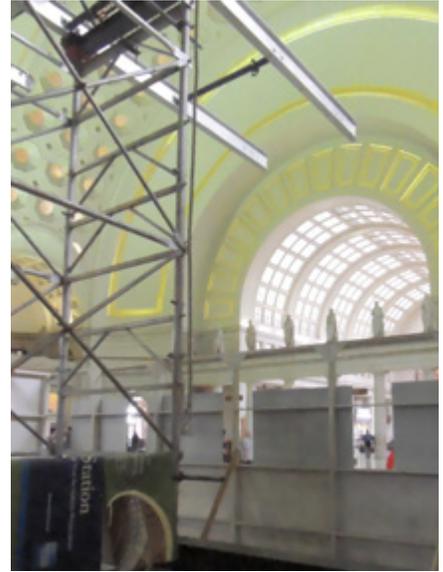
The second method employed the office elevator. Ductwork sections were deliberately fabricated by Linx or cut onsite to fit into the elevators. It was to the installers benefit that the smaller sections made the metal duct easier to handle. Both methods required 26" x 75" doorways to be cut into the historic building's plaster walls to reach above the dome for the HVAC repairs.

Jobsite materials were staged high above just outside the dome and on the scaffolding. Once the ceiling was deemed safe, Norwood's installation crew tore out the old duct system and replaced it with Linx Double Wall with the Lindab Safe gasket system. Modifications were made onsite and coordinated with the duct manufacturer in order to accommodate prefabricated duct supports and space constraints. "This project came with unusual design and fabrication needs. Linx has been great meeting these needs," said Norman.
